dsPIC33EPXXXGM3XX/6XX/7XX Family Silicon Errata and Data Sheet Clarification

The dsPIC33EPXXXGM3XX/6XX/7XX family devices that you have received conform functionally to the current Device Data Sheet (DS70000689D), except for the anomalies described in this document.

Note: This document summarizes all silicon errata issues from all revisions of silicon, previous as well as current. Only the issues indicated in the last column of [Table 2](#) apply to the current silicon revision (**A3**).

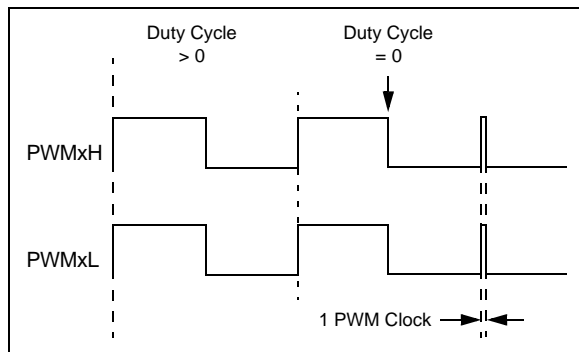
FIGURE 3:

In certain output modes, the PWMx module produces a pulse glitch of one PWM clock in width (Figure 3). This has been observed only when all of the following are true:

- Either Redundant or Push-Pull Output mode is selected ($\text{IOCONx}\langle 11:10 \rangle = 10$ or 01);
- Immediate Update is disabled ($\text{PWMCONx}\langle 0 \rangle = 0$); and
- The value of the current Duty Cycle register (either the PDCx or MDC register, as determined by $\text{PWMCONx}\langle 8 \rangle$) is updated to zero from any non-zero value.

The pulse glitch has been observed to occur at the beginning of the following PWM boundary period.

If the application requires a duty cycle of zero, two possible work arounds are available.

1. Use the PWM overrides to force the output to a low state, instead of writing a '0' to the Duty Cycle register. When using this method, the PWM override must be disabled when the duty cycle is a non-zero value. If output override synchronization is configured to occur on CPU clock boundaries ($\text{IOCONx}\langle 0 \rangle = 0$), enabling and disabling the override must be timed to occur as closely as possible to the PWM period boundary.
2. Configure the module for Immediate Update ($\text{PWMCONx}\langle 0 \rangle = 1$) before enabling the module. In this mode, writes to the Duty Cycle register have an immediate effect on the output. As with the previous work around, writes to the Duty Cycle register must be timed to occur as close to the PWM period boundary as possible in order to avoid distortion of the output.

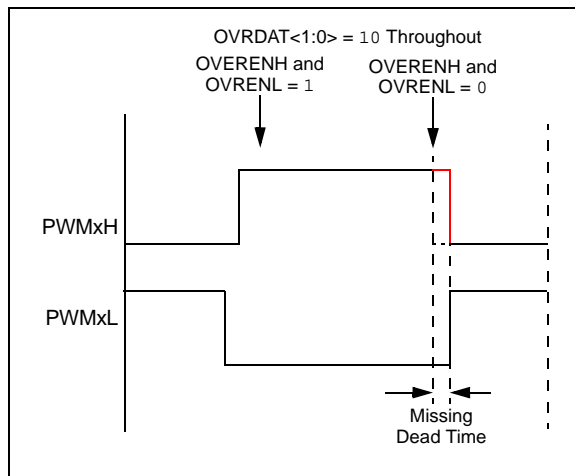
FIGURE 4:

In Complementary Output mode, the expected dead time between transitions of the PWMxH and PWMxL outputs may not be asserted when the following occurs:

- Output override synchronization is configured to occur on the CPU clock boundary ($\text{IOCONx}\langle 0 \rangle = 0$);
- Both PWMxH and PWMxL overrides are enabled prior to the event (OVRENH and OVRENL are both '1'), and
- Both overrides are disabled (OVRENH and OVRENL are both '0') at the instant the dead time should be asserted (Figure 4).

This has been observed in both Center-Aligned and Edge-Aligned modes.

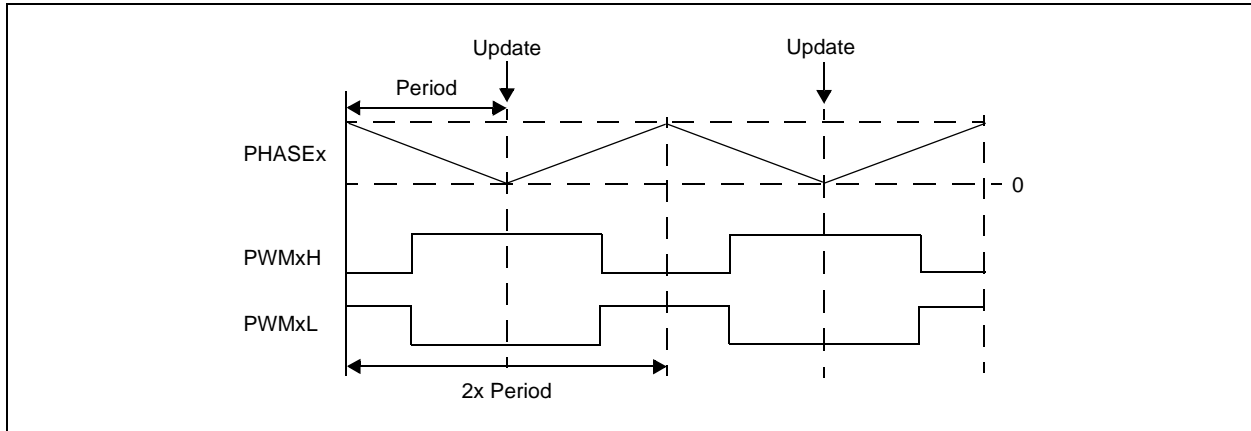
FIGURE 5:

In Center-Aligned Complementary mode with Independent Time Base, updates to the PHASEx register take effect in the middle of a Center-Aligned PWM cycle, as shown in Figure 5. This occurs only when the Immediate Update feature is disabled (IUE = 0). If Immediate Update is enabled (IUE = 1), the PHASEx register updates will take effect immediately.

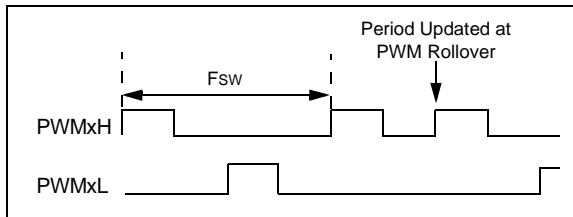
FIGURE 6:

When the PWM module is configured for Push-Pull mode (IOCON<11:10> = 10) with the Enable Immediate Period Update bit enabled (PTCON <10> = 1), a write to the Period register that coincides with the period rollover event may cause the push-pull output logic to produce back-to-back pulses on the PWMx pins (Figure 6).

Ensure that the update to the PWM Period register occurs away from the PWM rollover event by setting the EIPU bit (PTCON<10> = 1). Use either the PWM Special Event Trigger (SEVTCMP) or the PWM Primary Trigger (TRIGx) to generate a PWM Interrupt Service Routine (ISR) near the start of the PWM cycle. This ISR will ensure that period writes do not occur near the PWM period rollover event.
